EVANSTON PUBLIC LIBRARY Building Reserve Analysis — 2018 Update

Evanston, Illinois

Revised Report

WJE No. 2018.1775

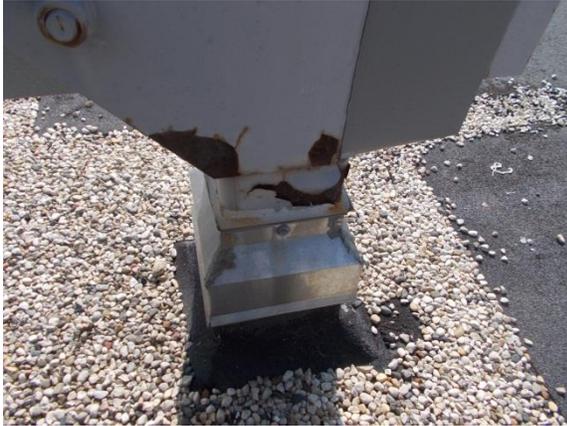
- 04-03. Surface corrosion was observed on the structural steel framing that supports the metal panel sound attenuation wall at the roof level chiller enclosure (Figure 1). At other areas, the paint coating on the structural steel members was chalked or missing.
- 04-10. Peeling paint was observed on the gypsum board soffit at recessed window openings on the south exterior wall.

Figure 1. Corrosion on the surface of the structural steel supporting the sound attenuation wall.

- 04-03. The exposed structural steel framing that supports the metal panel sound attenuation wall should be repainted. The surface should be prepared to remove corrosion, and the steel should be primed and painted.

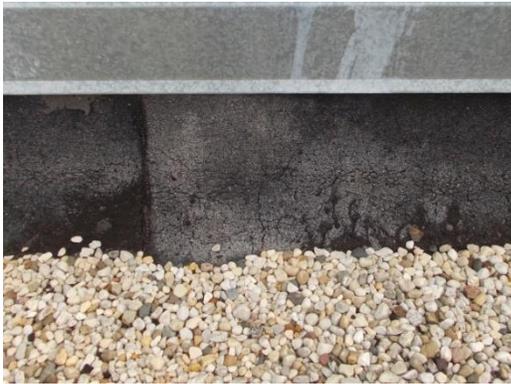
Figure 2. Cracking on the surface of the upturned roofing

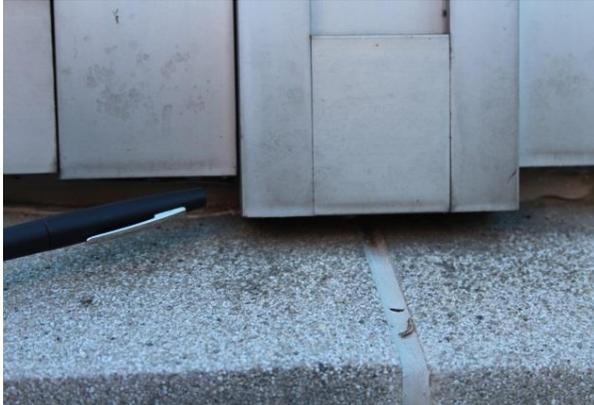
Figure 3. A window mullion on the east facade that has shifted downward.

- 08-01. When observed, any displaced window components should be gently tapped with a rubber mallet to return them to their original alignment. This will help ensure that the intended secondary drainage pathways in the window system design are functional.

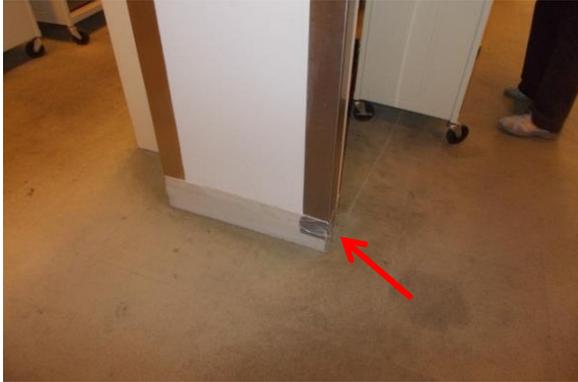
Figure 4. Sheet metal corner guard does not extend to the baseboard. The baseboard in this location has been repaired with duct tape.

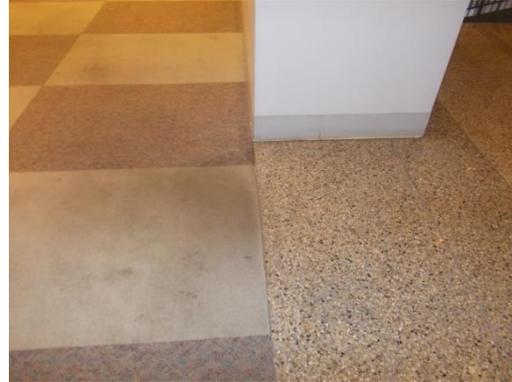
- 09-04. At many locations, the rubber wall base is split and detached from the wall, particularly in high-traffic areas.
- 09-05. Most areas of carpet are worn, discolored, and nearing the end of their serviceable life (Figure 5).

Figure 5. Typical worn and stained condition of carpeting, second floor near service desk.

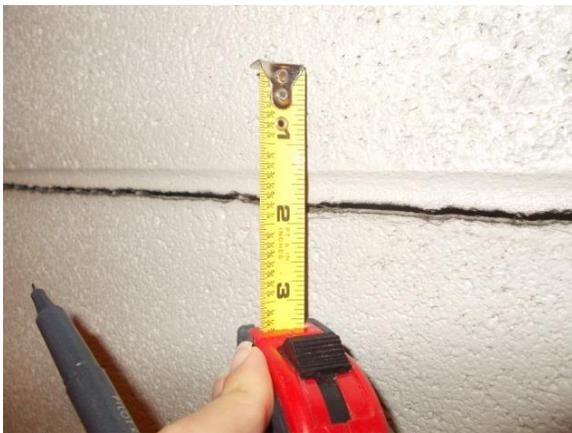
- 09-06. An open horizontal crack was observed in the non-structural concrete masonry wall at the east wall of the fourth floor boiler room (Figure 6). This crack may indicate movement of the wall or floor system. Per the original drawings, the floor system in this area is a 12 inch thick two-way reinforced concrete slab. The partition wall itself is a non-structural 6 inch thick wall located 28 inches west of column line 3.

Figure 6. Open crack in the concrete masonry wall between the fourth floor mechanical and air handling rooms.

- 09-06. The cracked non-structural concrete masonry partition wall located in the boiler room should continue to be monitored over time. A crack gauge installed in the boiler room shows no additional displacement as of 2018.

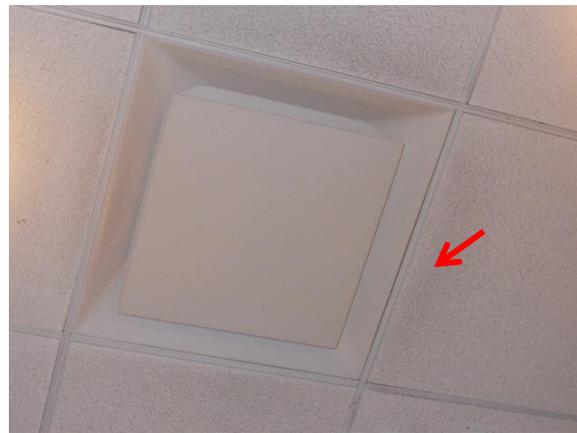
- 09-07. Discoloration and dirt is present on acoustic ceiling tiles surrounding air supply and return vents (Figure 7).
- 09-08. General surface wear and markings were observed at many of the gypsum board and plaster wall finishes.

Figure 7. Dirt present on tile adjacent to a ceiling vent.

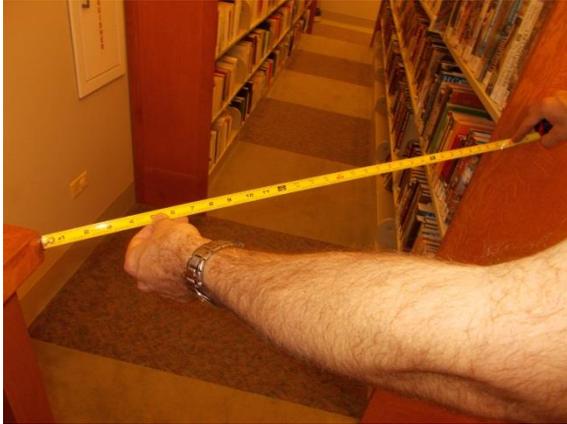
- 10-01. Movable furniture was observed to obstruct some aisles and not allow for a minimum 30 inches of clearance at all locations (Figure 8).
- 10-04. Handrail extensions do not always return to a wall, guard, or landing surface (Figure 9).

Figure 8. Clear travel path between bookshelves and other furnishings or fixtures should be 30 inches minimum.

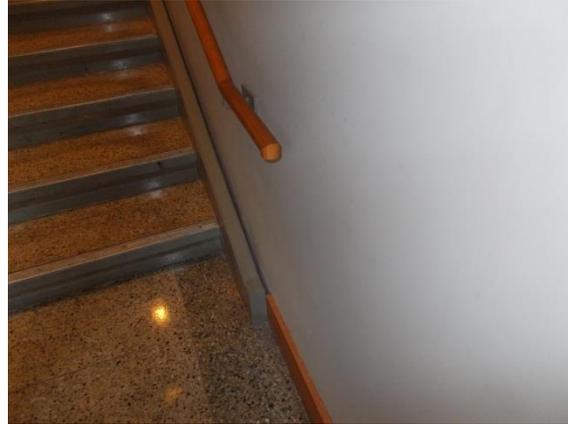
Figure 9. Existing hand rail extends beyond the bottom riser and stops abruptly. The 2010 ADA standards require that the handrail return horizontally to the wall surface at right.

- 10-04. Wherever existing handrails are affected by other renovation work, they should be modified so that extensions return to a wall, guard, or landing surface.

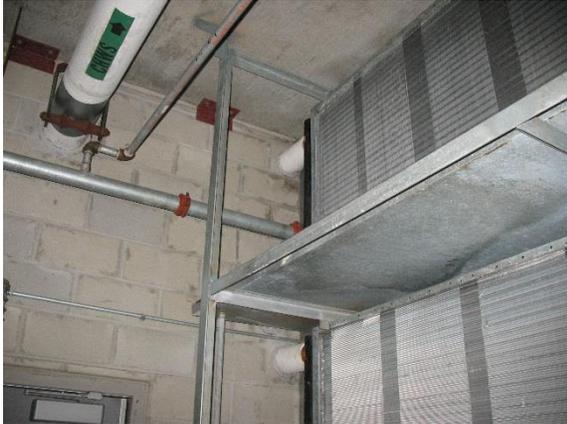
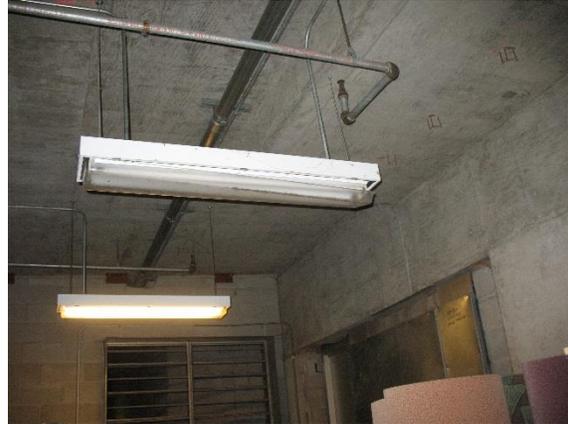
The piping in the fourth floor mechanical/air handler room has corroded fittings and supports (Figure 10 and Figure 11). As noted in a previous inspection, none of the desiccant dryers are currently functional. The fire pump is original and has been regularly tested (Figure 13). The jockey pump has been replaced sometime since the original installation. The dry valves have been regularly tested, and the small system serving the loading dock has a replacement air compressor. Heads in finished spaces, in general, appear clean. Heads in mechanical spaces generally appear dusty (Figure 14). **Since the 2013 report was prepared, further deterioration of the dry sprinkler system has been observed, and replacement of the piping is now recommended.**

Figure 10. Dry sprinkler piping in mechanical plenum.

Figure 11. Dry sprinkler piping in mechanical plenum.

- 21-06a. During the next scheduled five-year maintenance service of the dry sprinkler system, the dry system piping, hangers, and supports at the fourth floor mechanical wing should be replaced.

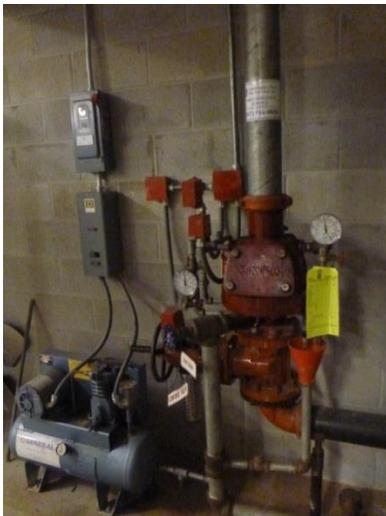
Figure 12. Dry valve and compressor serving fourth floor dry system.

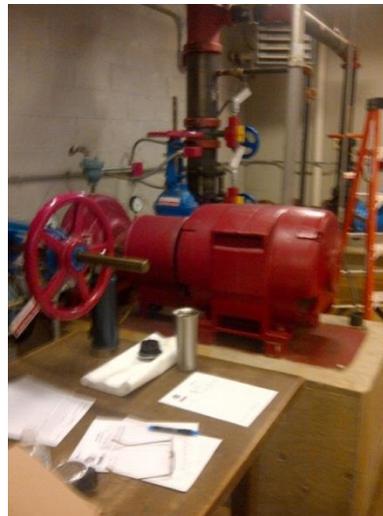
Figure 13. The fire pump assembly.

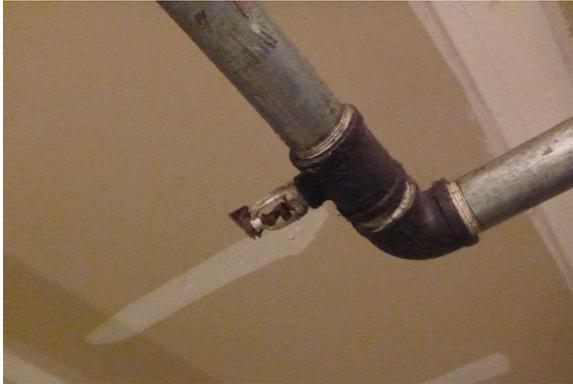
Figure 14. Side outlet sprinkler head in mechanical space.

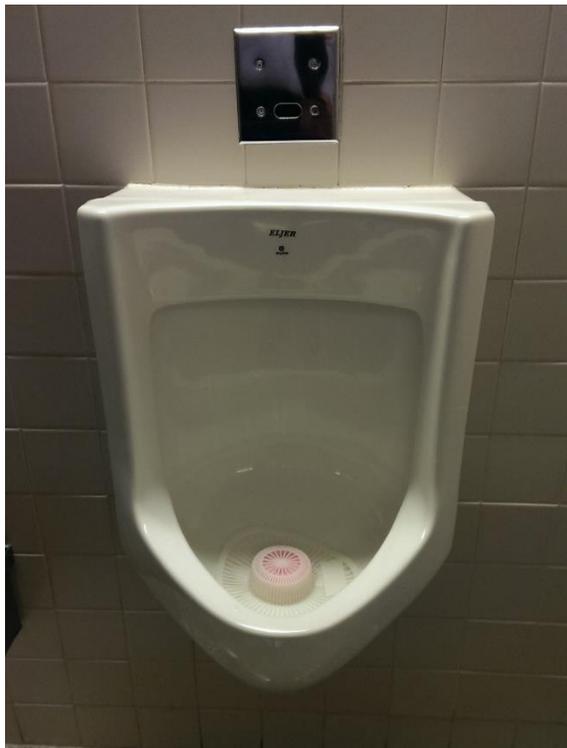
Figure 15. Typical wall hung urinal with concealed sensor operated flush valve.

- 22-06. When required due to wear or damage over the next five to ten years, the existing plumbing fixtures should be replaced.
- 22-08. Within the next five to ten years, cleaning and repair of the two sewage ejector pumps and the one garage sump ejector pump should be performed. This work will likely include replacement of the piping within the sump basin at each pump.

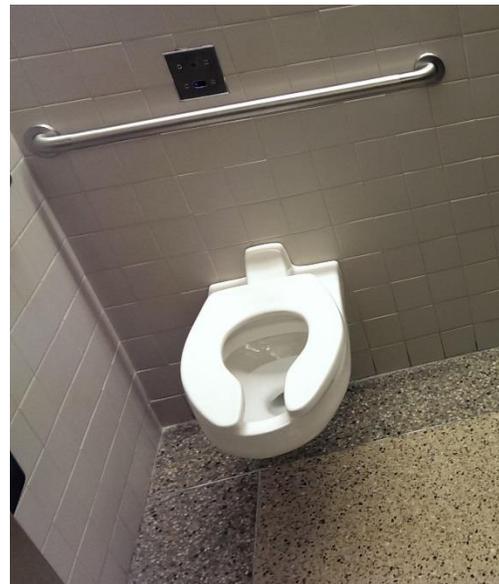
Figure 16. Typical wall hung toilet with concealed sensor operated flush valve.

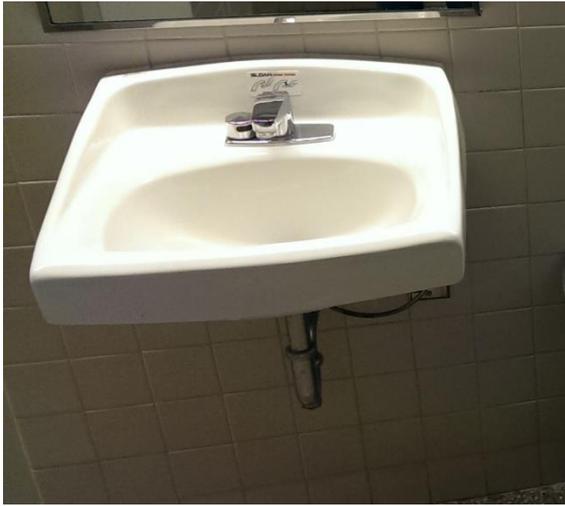
Figure 17. Typical wall hung lavatory with sensor operated faucet.

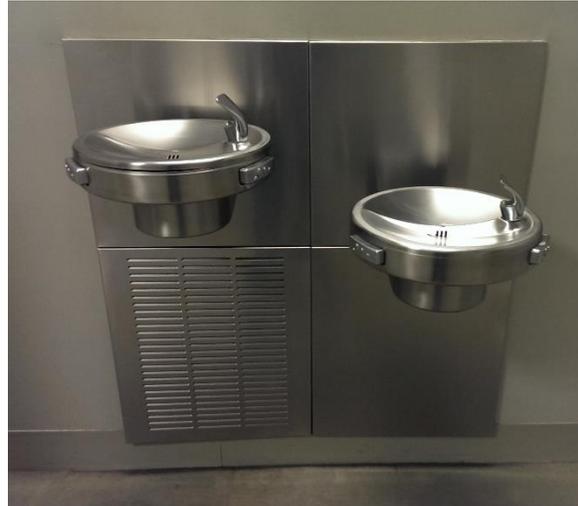
Figure 18. Typical existing electric water cooler.

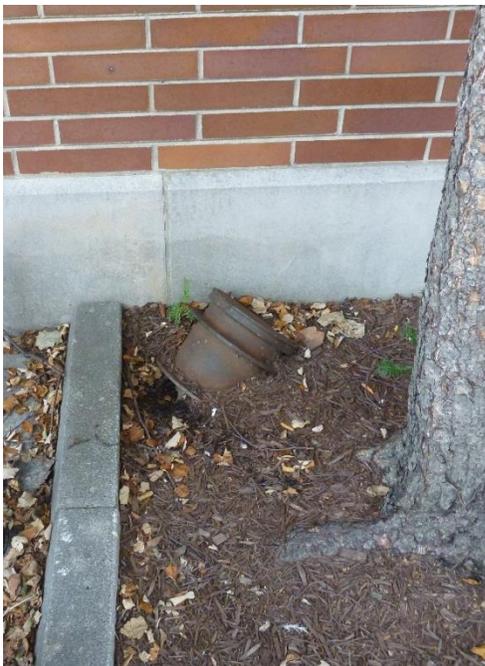
- 22-01. The booster pump, sump pump, and sewage ejector are not part of the building automation system.
- 22-03. Almost all of the grade cleanouts serving the foundation drainage system have heaved out of the ground (Figure 19).
- 22-06. The life expectancy of typical commercial plumbing fixtures is anticipated to be fifteen to thirty years.
- 22-07. Properly designed copper pipe potable water systems should last the life of the building. (Improperly designed piping would likely fail before twenty years of use, and no previous or existing water piping failures have been reported.)
- 22-08. The self-priming duplex sump pump system has a failing flexible coupling.

Figure 19. Typical foundation drainage grade cleanout heaved out of the ground.

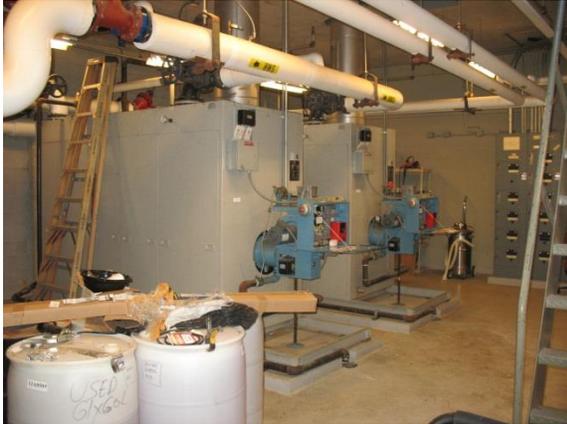
- **23-18.** Boilers are reported to be in working condition, with limited major maintenance and annual safety checks and cleaning performed on the system (Figure 20). An internal inspection of the tubes on the fireside revealed extensive rust build-up. Rust build up was particularly prominent on boiler B-2, the boiler closest to the hot water return (Figure 21). Rust build up is an indication of condensing operation and can lead to premature failure. The reset temperature for the boilers and the system should be raised so that return water does not drop below 130 degrees Fahrenheit. No pipe pitting and very little soot was observed in the fireside chamber. The boiler gas train, burners and controls appeared to be in good condition. It is imperative that scheduled routine maintenance be done on the boilers to keep the system operating efficiently. While a detailed maintenance schedule for the boilers

Figure 20. Boiler room.

Based on recent inspections, replacement of the boilers within approximately the next five years is anticipated.

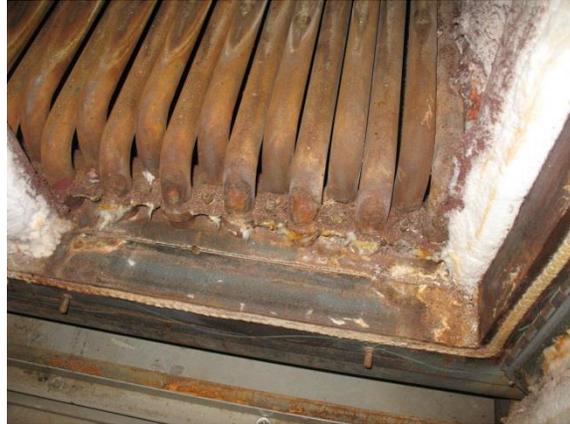
Figure 21. Corrosion on fire side of boiler tubes.

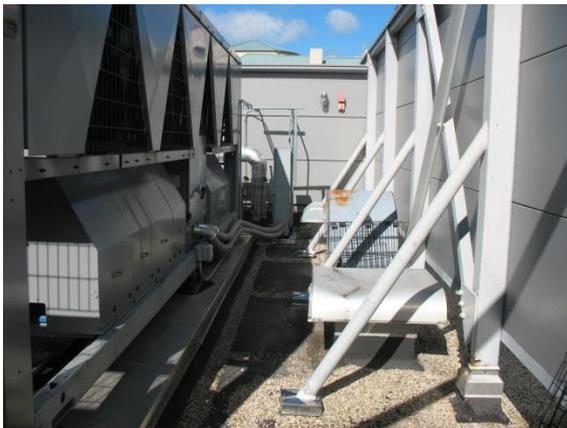
- Original building air cooled chillers were replaced in 2010 by the current air cooled chillers with scroll compressors (Figure 22). Rooftop piping was replaced along with the chillers. Chillers are reported to be in good condition, and should provide dependable operation with only routine maintenance for the next twenty years or more.

Figure 22. Air cooled chiller.

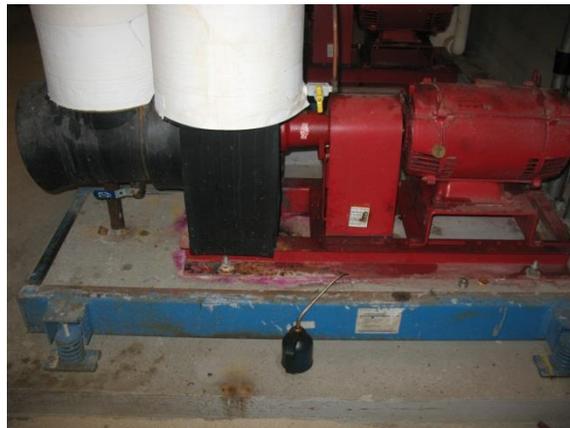
- **23-13.** Chilled water pumps are original to the building. The bearings have already been replaced for both chilled water pumps P-1, and P-2. The baseplate for pump P-1 had peeling paint due to glycol leaks in the past (Figure 23). Since the pumps will exceed their median service life expectancy in the next ten years, it would be prudent to replace the chilled water pumps in the next few years.

Figure 23. Chilled water pump P-1.

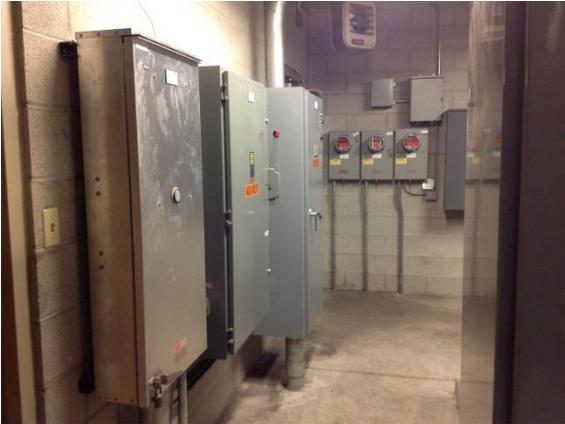
- Meter #141682884. This meter serves the entire facility through switchboard B-SWBD-H1 (Figure 24). Derived from a pad-mounted transformer located outside. 3000A, 480/277V, 3-phase, 4-wire, with recently replaced ground fault protection. Also feeds 400A Automatic Transfer Switch (ATS) EHD and 600A ATS 4-SMCC-1. Switchboard has three spaces for 400A fused switch each.

Figure 24. Electrical Room.

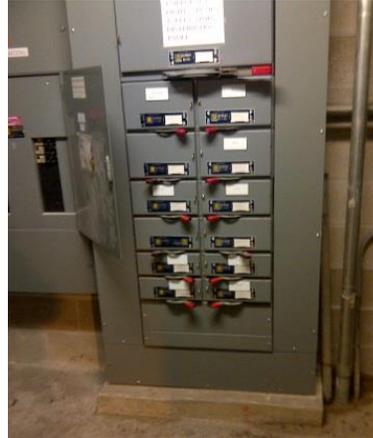
- Meter #141682883. This meter serves emergency lighting, elevators, miscellaneous pumps, (i.e. jockey, sewage ejector, sump pump, etc.) and feeds panel EHD (Figure 25). Square-D, 400A, 277/480V, 3-phase, 4-wire, located in separate electrical room across from the main electrical room. Panel EHD has one 200A, and two 100A spare switches.

Figure 25. ATS-EHD-1.

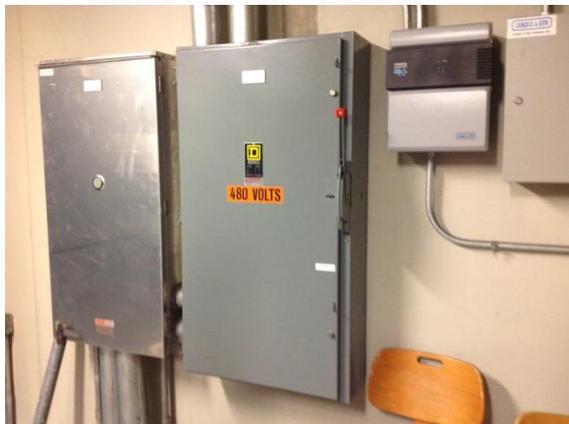
- Meter #141244129. This meter serves the supply and return fans of the facility, motor control center 4-SMCC-1. 600A, 480/277V, 3-phase, 4-wire, Square-D motor control center, is located on the fourth floor (in the corridor south of the mechanical room) with space for one Hands-Off-Auto (HOA) combo starter, and three 100A spaces for fused disconnect switches (Figure 26 and Figure 27).

Figure 26. Square-D motor control center.

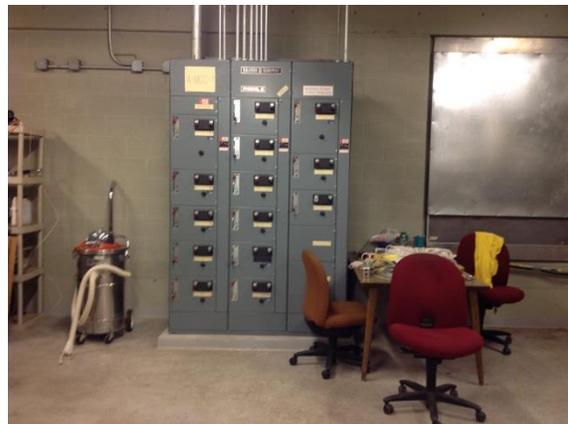
Figure 27. Switchboard 4-MCC-1.

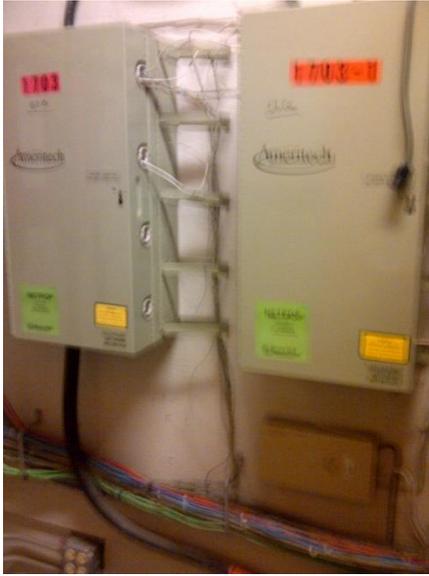
AT&T service is located in the first floor IT room (Figure 28 and Figure 29). The second, third, and fourth floor IT closets are vertically stacked. The IT rooms are all open to the return air ceiling plenum.

Figure 28. Ameritech telephone equipment found in IT Room.

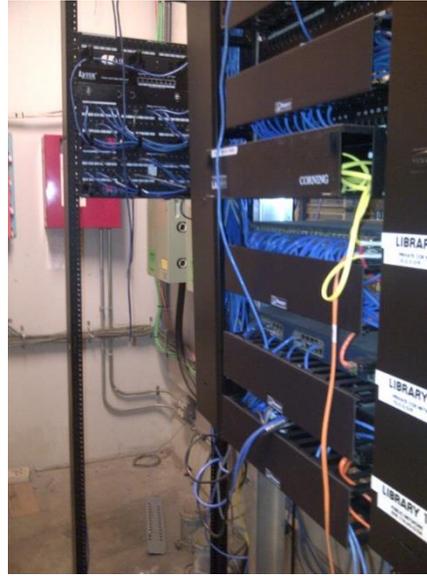
Figure 29. Single rack in IT Room.

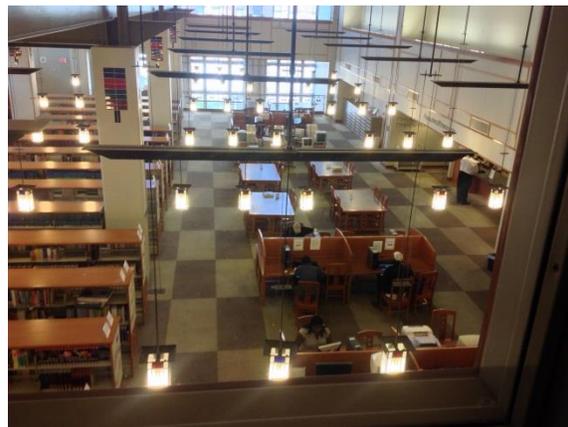
located in the respective electrical room (Figure 30 through Figure 32). Exit and emergency lights were noted to be appropriately located.

Figure 30. Pendant lighting over study areas.

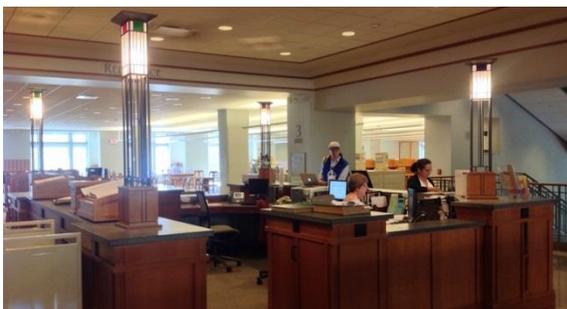
Figure 31. Lighting at lobby area.

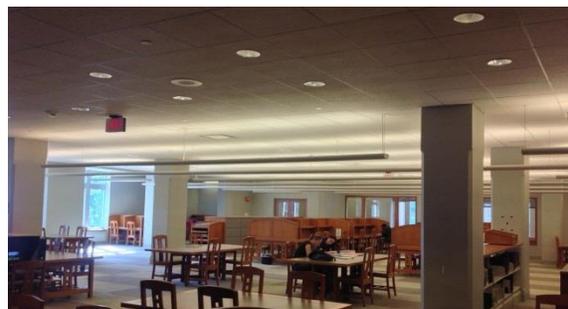
Figure 32. Downlights at study areas.

- 26-04. The customer meter should be replaced with Square-D “ION” meter, interfaced with the building automation system.
- 26-05. Many of the recessed downlights throughout the building are fluorescent fixtures with integrated ballasts. Therefore, the existing fixtures cannot be readily re-lamped with more efficient LED lamps. These fixtures should be replaced. Due to the disruptive nature of fixture replacement, which will require at least localized dismantling and repair of ceiling finishes, fixture replacement should be undertaken as part of major interior renovation work, and is not included in this Building Reserve Analysis.

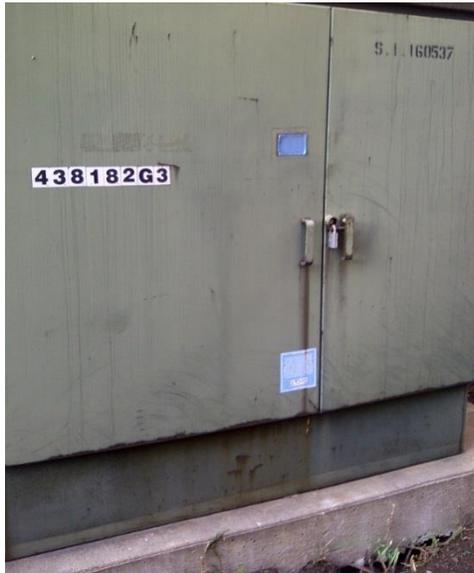
- 26-01. The concrete pad under the service transformer at the rear of the building has been undermined by vermin (Figure 33 and Figure 34).
- 26-04. The original customer metering that was intended to permit facilities staff to monitor electrical usage is not operational.
- 26-05. In the main stairwell, some but not all recessed lights were observed to be retrofitted with LED lamps.
- **26-06. The bonding clamp for the electrical grounding at the water service entry has corroded.**

Figure 33. Transformer.

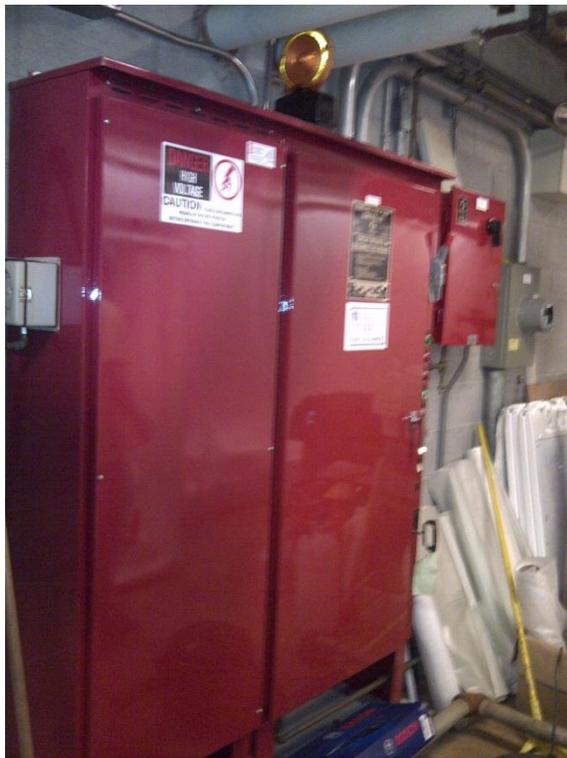
Figure 35. Main fire pump apparatus.

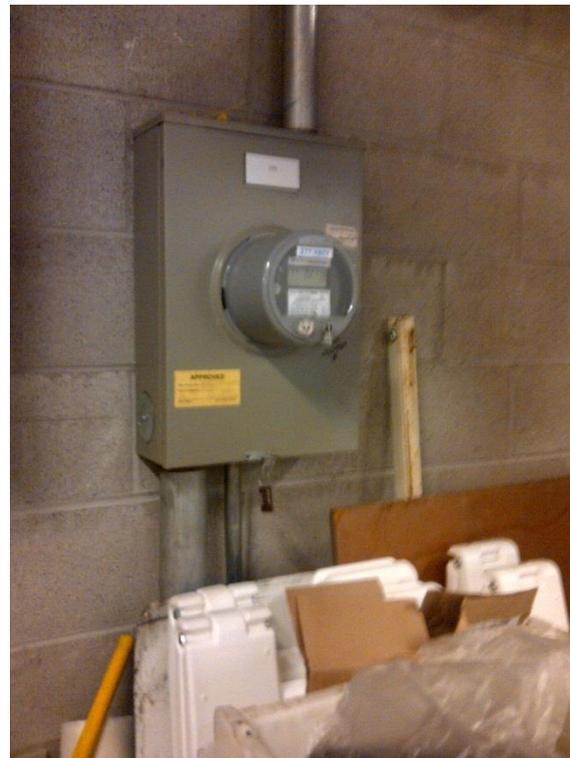
Figure 36. Meter.

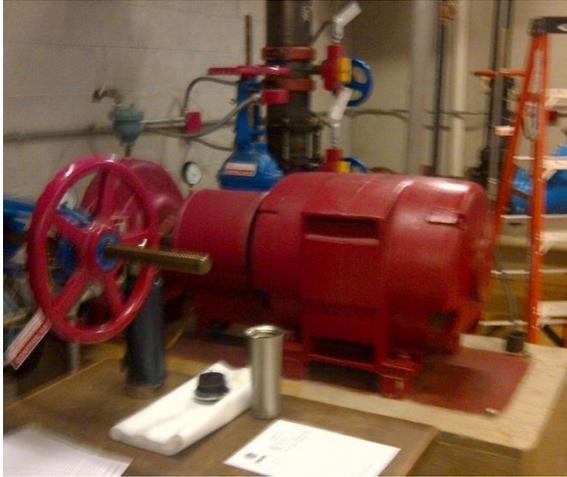
Figure 37. Fire pump.

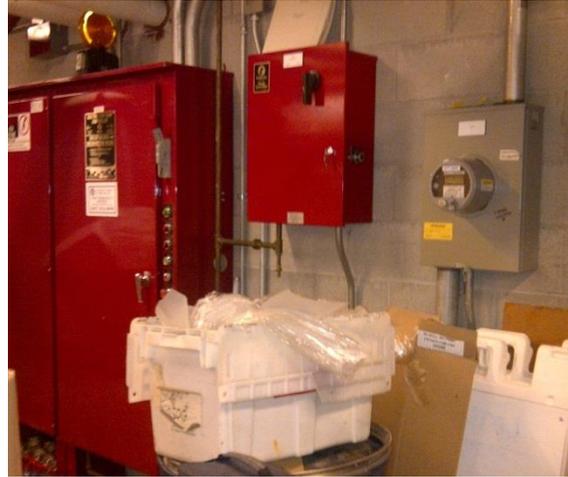
Figure 38. Automatic transfer switch.

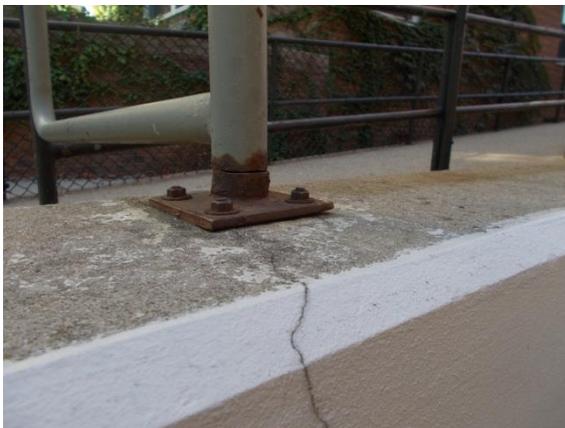
Figure 39. Corrosion of the guardrail and crack in the concrete retaining wall.

- 32-11. The north concrete retaining wall should be repainted with an elastomeric coating. Existing cracks that are too wide to be bridged by the coating should be repaired prior to coating.
- 32-14. The health of the mature trees at the perimeter of the building should be monitored. By the end of the ten-year period covered by this plan, the existing birch trees will be approaching the end of their expected forty-year life.

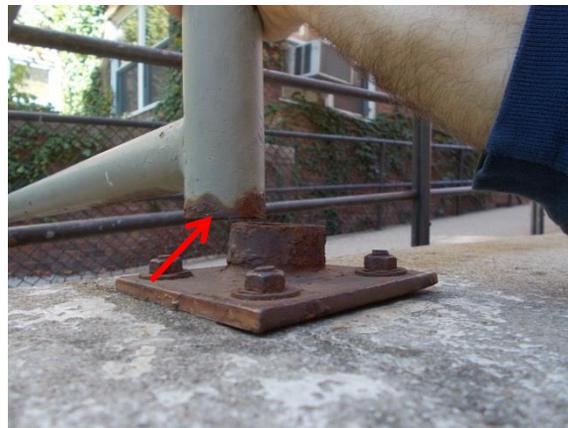
Figure 40. Corrosion related failure of the guardrail connection on the north retaining wall.

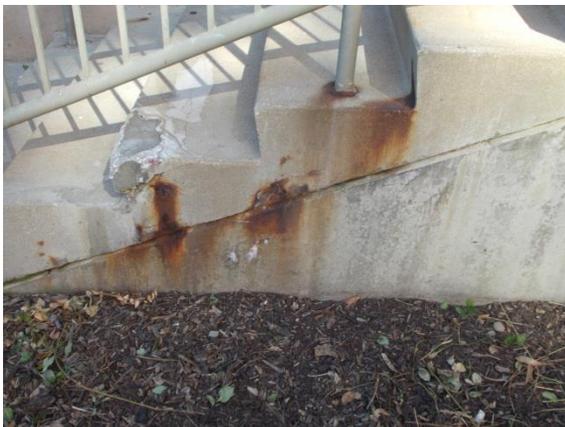
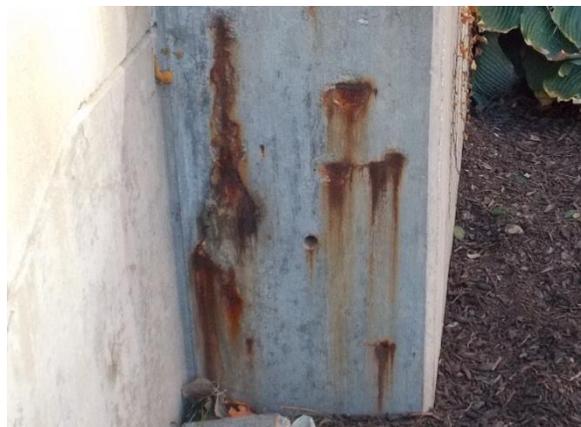
Figure 41. Ferrrous staining on the surface of the concrete at the north stoop.

Figure 42. Ferrrous staining on the surface of the concrete at the north stoop.

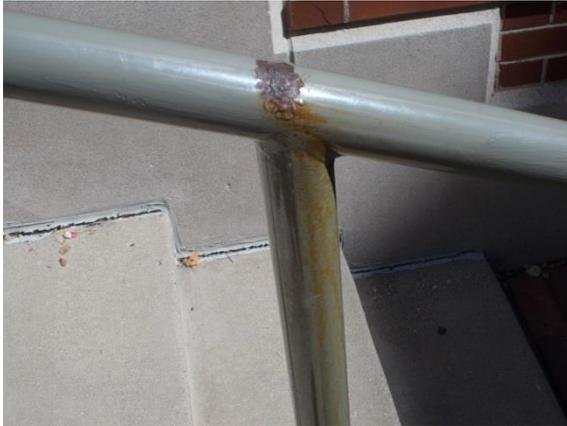
Figure 43. Typical handrail surface corrosion.

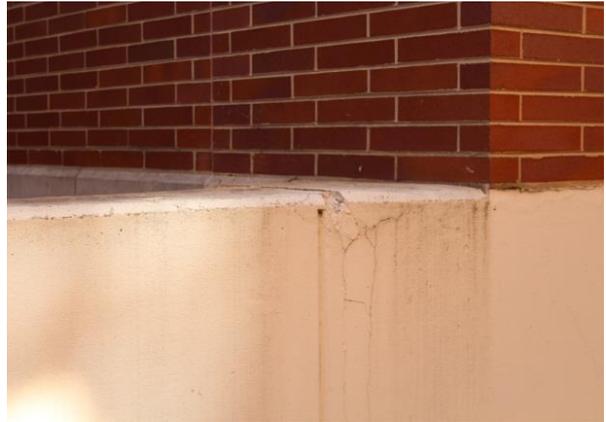
Figure 44. Crack in a north side retaining wall.
